FREQUENTLY ASKED QUESTIONS
(Rainier Screen Systems)

Field Troubleshooting Guide

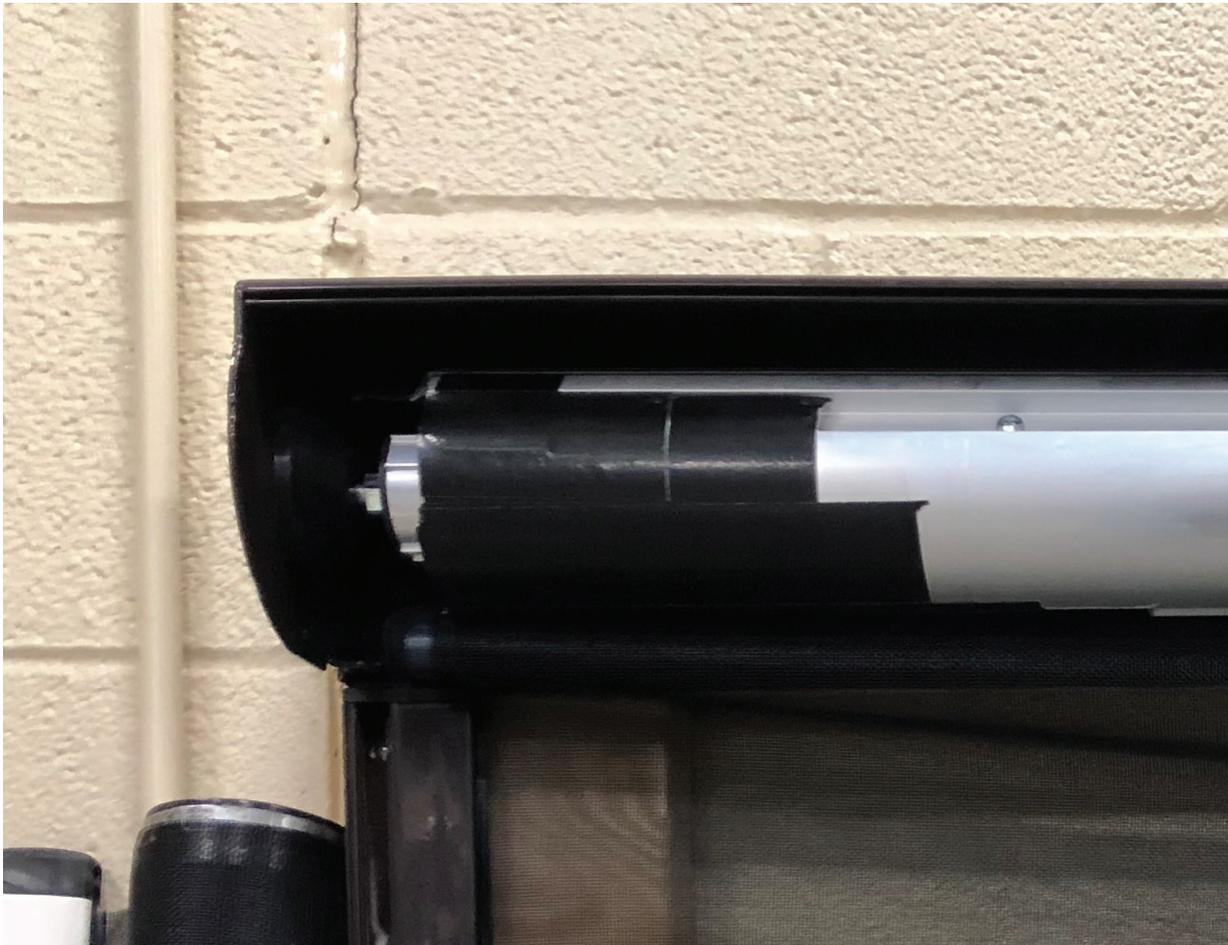
Start with a small piece at the end and test it out, then add more as necessary. If you require multiple pieces of tape, Rainier recommends stair-stepping your pieces of tape as shown in photo, as opposed to stacking tape on top of itself. This helps minimize wrinkling/stretching of the fabric.

- 1. Check install (level housing, plumb tracks, track alignment, centered fabric)*
- 2. If install is perfect, check again*
- 3. If install is still perfect, check weight bar to make sure steel inside didn't slide to one side during shipment or install.*
- 4. As a last resort, using a fabric shim, shim the roller tube on the low side to bring up hem bar faster on that side. Most people use either a strip of quality duct tape such as Gorilla tape, or scrap piece of fabric if available. Run the screen all the way down and apply the shim directly to the roller tube (under the fabric) on the end that doesn't retract up as far.*
